# SusCheck Photo Pre-Screen Report

**Vehicle: Travel Trailer / Fifth Wheel**

Date: 9/21/2026 Pre-screen: 330eb94b-0419-43a8-8319-a58306f210bd

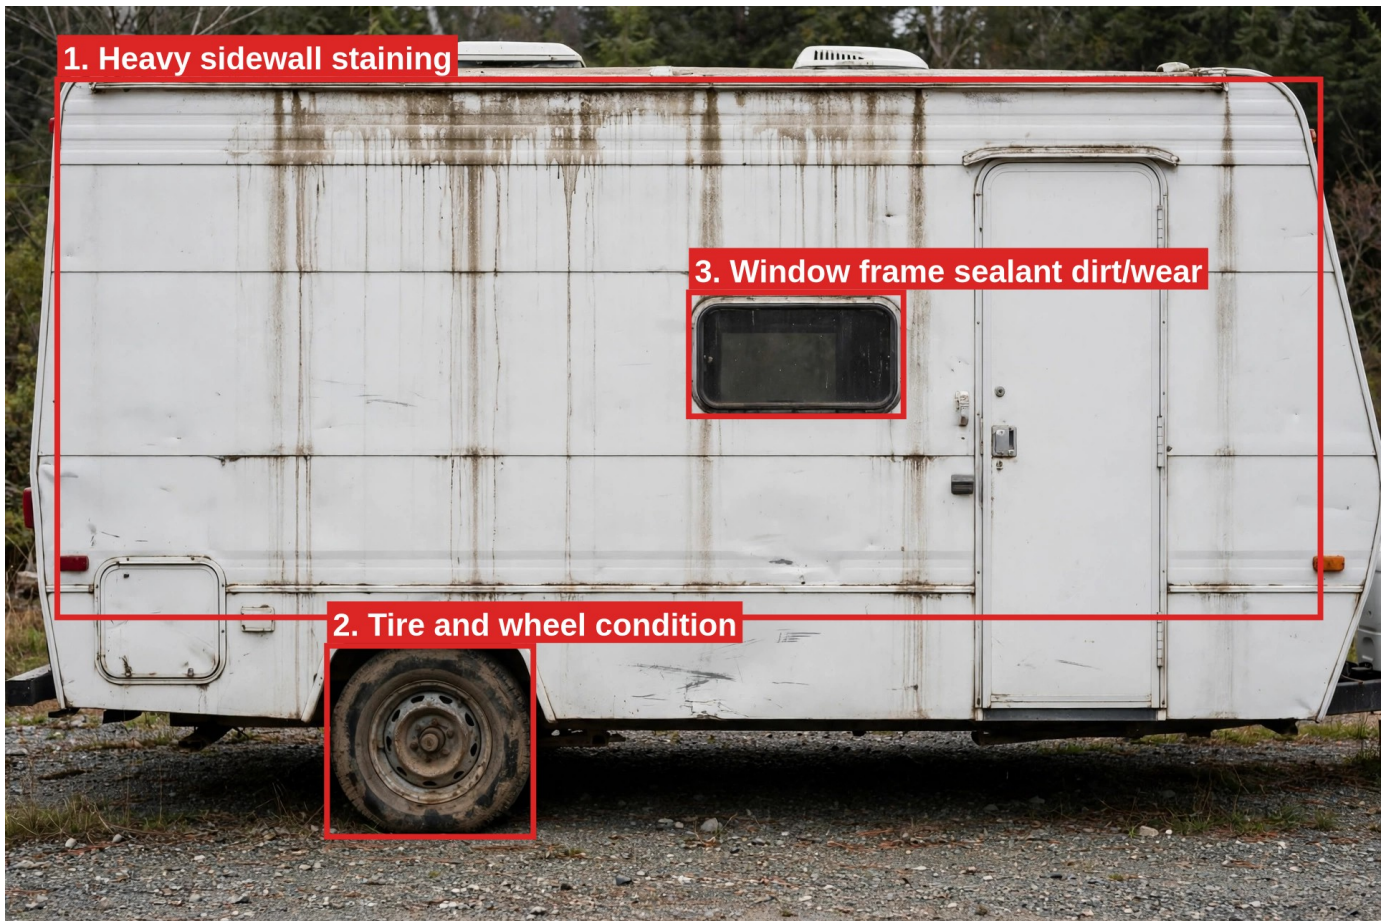
## Photo 1

Exterior sidewalls — delamination: Monitor — Watch — Heavy runoff streaking and minor panel dents visible, but aluminum siding does not show delamination.

Windows, entry & compartment doors: Monitor — Watch — Seals around windows and door are heavily stained with grime; check flexibility and adhesion closely.

Exterior side view of a vintage travel trailer showing heavy staining and weathering.

1. Heavy sidewall staining: Extensive dark streaks running down the exterior siding, indicating significant water run-off and roof grime accumulation.
2. Tire and wheel condition: Tire appears aged and dirty on a rusted steel wheel; sidewall condition and date code require closer inspection.
3. Window frame sealant dirt/wear: Heavy grimy buildup around window perimeter frame and seals.

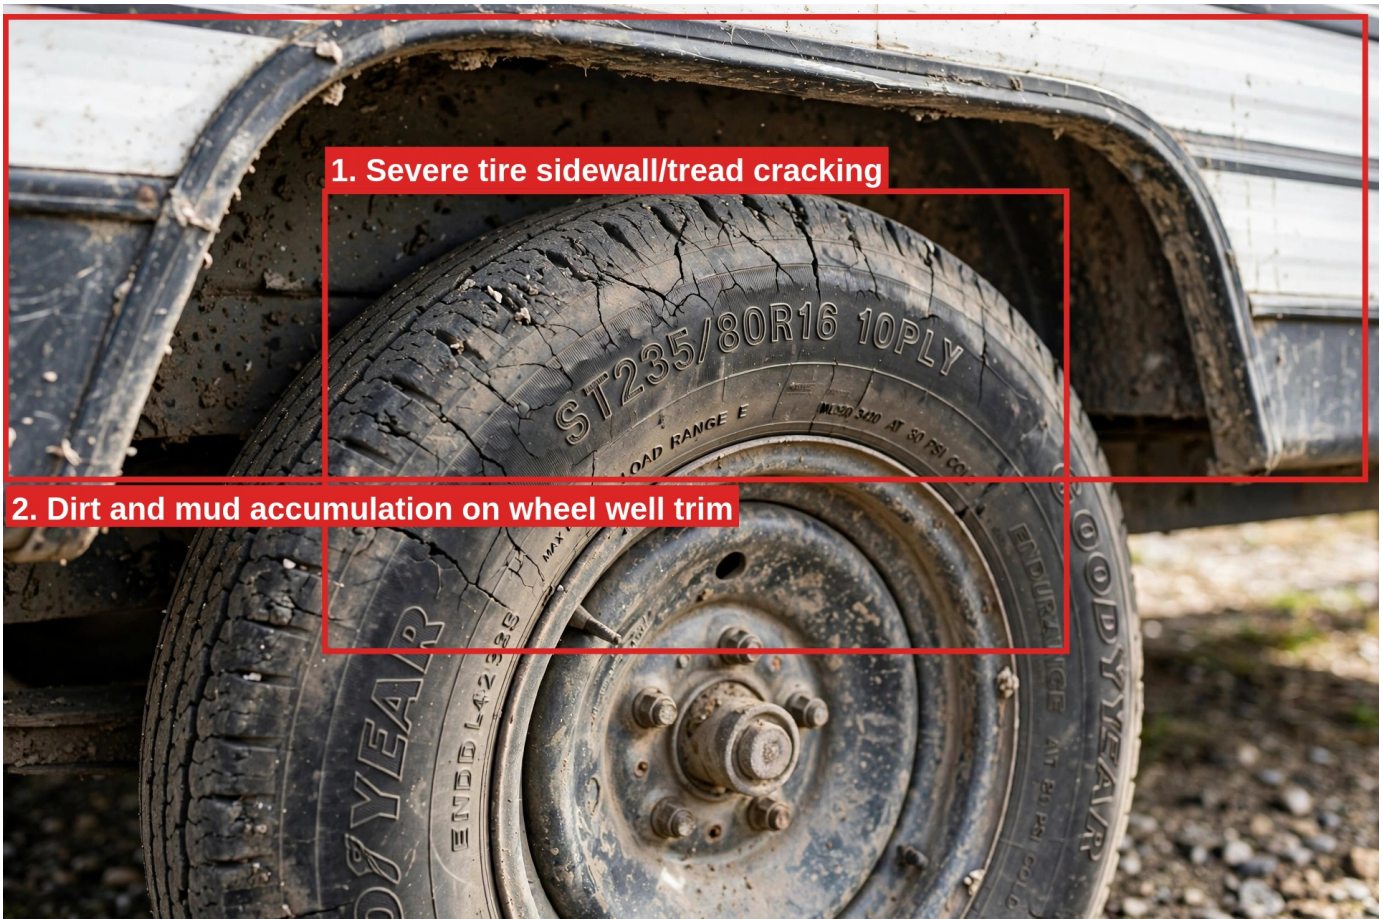
## Photo 2

Tires: Repair — Repair soon — Deep sidewall and shoulder cracking indicates advanced rubber degradation requiring immediate replacement before towing.

Close-up view of a trailer tire, wheel well, and lower sidewall trim.

1. Severe tire sidewall/tread cracking: Extensive, deep dry-rot cracking is visible across the shoulder and tread area of the tire, presenting a blowout risk.
2. Dirt and mud accumulation on wheel well trim: Lower skirt and fender trim are dirty and splattered with mud, though no major body damage is visible.

- Roof membrane & seams (Repair, Repair soon): The sealant along the roof edge seam is severely cracked and degraded, creating potential points for water intrusion.
- Tires (Repair, Repair soon): Deep sidewall and shoulder cracking indicates advanced rubber degradation requiring immediate replacement before towing.

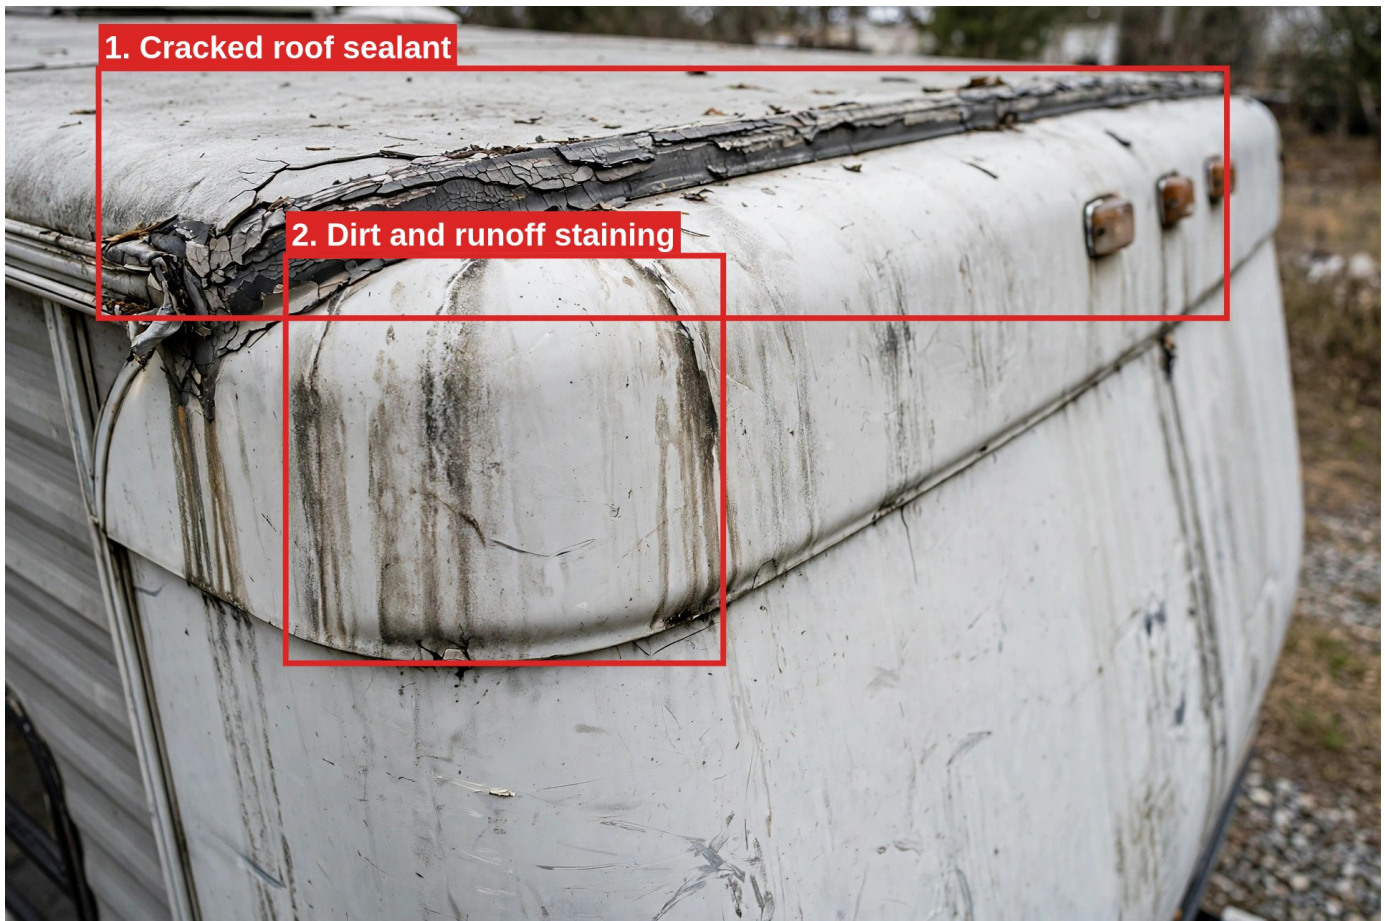
### Photo 3

Roof membrane & seams: Repair — Repair soon — The sealant along the roof edge seam is severely cracked and degraded, creating potential points for water intrusion.

Close-up view of the upper front corner and roof seam of an older travel trailer.

1. Cracked roof sealant: Severe cracking, peeling, and separation of sealant along the roof edge molding seam
2. Dirt and runoff staining: Heavy dirt buildup and vertical black runoff stains down the front cap
